Glider Mission Summary Report

SOCIB_CANALES_MAY2016 (GF-MR-0045)

Balearic Islands
Coastal Observing
and Forecasting
System

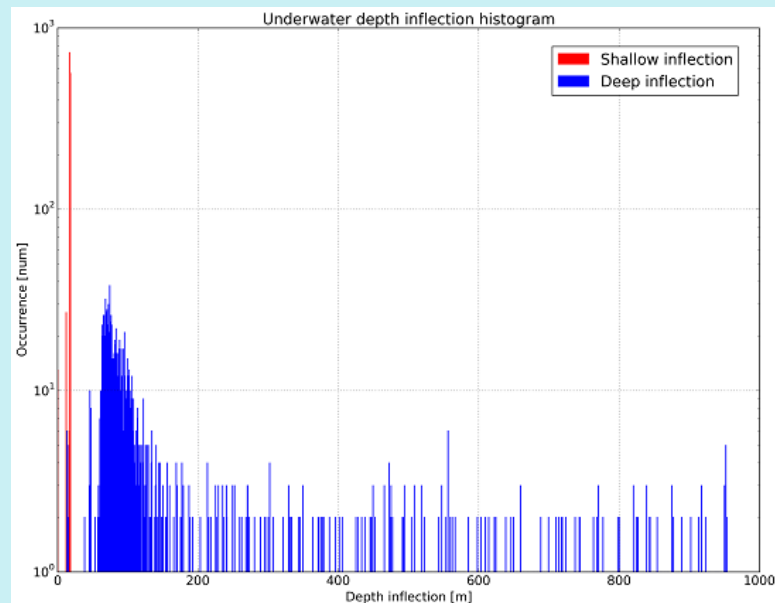
Figure 1 - Diving Max-Depth Histogram

- Underwater Maneuvering:** was initially configured accordingly to scientific objectives, environmental conditions (mainly bathymetry for this mission) and 'flying' efficiency. (See Chart 1 for details). During the mission the strategy was slightly changed multiple times to adapt to variations in these aspects (mainly flotation parameters to fly more efficiently). Basically, a standard configuration (surface by UTC time, 4 times a day, infinite yo-ing, altimeter on, manual pitch control) was implemented. Average vertical speeds of 0,15m/s (climbing) and 0,19m/s (diving) were accomplished resulting in a mean horizontal speed of 0,293m/s. Both target depths (upper and bottom) remained constant during the main part of the mission (15 and 950 meters respectively). In general, top and bottom inflections occurred at the expected depths (due to bottom detection or max. depth reached). However, during the last part of the mission some undesirable events occurred: (1) underwater software reset by Watchdog device; (2) Bottom hit due to pump failing from starting-up and (3) a series of aborts the day before the emergency recovery. The cause of all of these successes has been stated as a poor energy supply by a decaying voltage of on-board Lithium batteries.

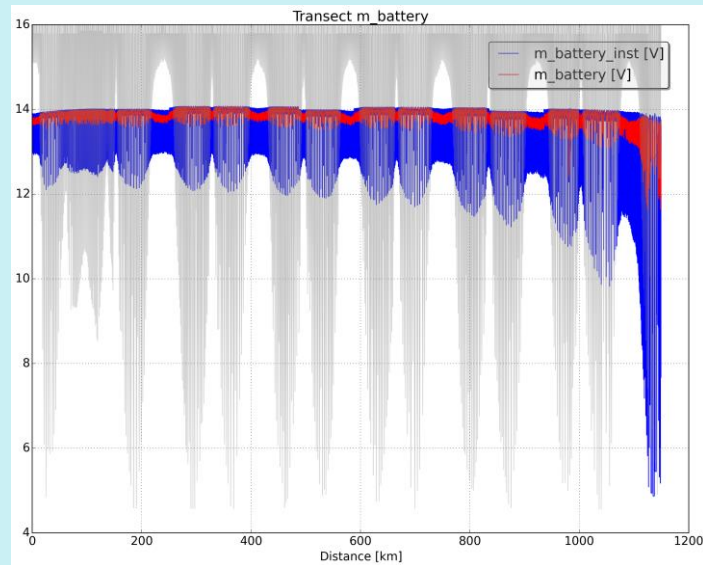
Figure 2 - Battery evolution and decay

- Power Source: Brand new Primary Lithium Battery pack with, as considered prior to the mission, 420Ah of nominal capacity. After this experience, the nominal capacity of the packs from this manufacturer are considered usable only until depleting 310Ah The supply was stable and capable of fulfilling the requirements of all the on-board systems until the 10th IC transect. After that, SDEEP00 should have been commanded to return to home-port. But it wasn't (relying on a false greater capacity) so the 'depletion-knee' appeared in the middle of the 12th IC transect whilst it was already obvious during the 11th one. Finally, glider operation became unfeasible passed when consumption reached 311Ah.

This was an emergency extraction motivated by a failure of the Lithium batteries. After 48 hours of an abnormal Glider aborts, it was quickly arranged and executed on June-24th in N39° 00.545' E00° 37.196' (See "MISSION ABORT/END" position in Figure-2). A team formed by 1-ETD and 1-GF departed early in the morning and cruised (on board SOCIB-I RIB) for 4,5 hours until interception (Glider was already at surface waiting) and was extracted with no problem availing a favorable sea-state. SDEEP00 performed a series of shallow dives, during that cruise, to minimize the risk of hovering at surface.

Remarkable: (1) The Lithium batteries 'died' when 310Ah had been consumed and the appearance of the 'depletion knee' is the official cause of the voltage failure which provoked the recovery. See Figure 2. (2) The Digifin and Tail-boom appeared severely bent to Starboard. Due to this deformation the Cowling also suffered damages. Glider manufacturer has been contacted to this regard and telemetry carefully analyzed. However, there is not an official explanation about what forces (and their origin) could have done such damage. The most likely ultimate consequence is the glider being sent to factory for repair and opportunistic refurbishment.

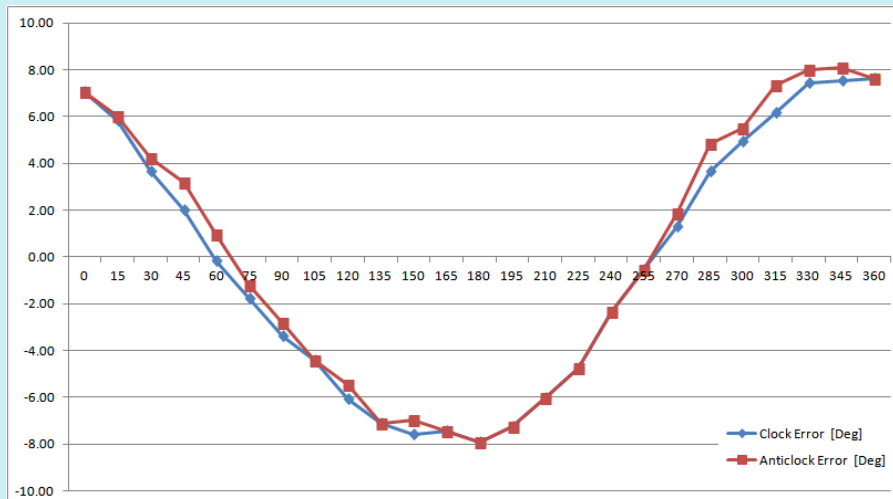
Figure 3 - Error measured during Compass Error Check procedure in an electromagnetic-field-free environment located in a forest close to IMEDEA (in Esporles)
