Glider Mission Summary Report

CANALES NOV 2017
SOCIB GLIDING NOV2017 (GF-MR-0065)

Balearic Islands
Coastal Observing
and Forecasting
System

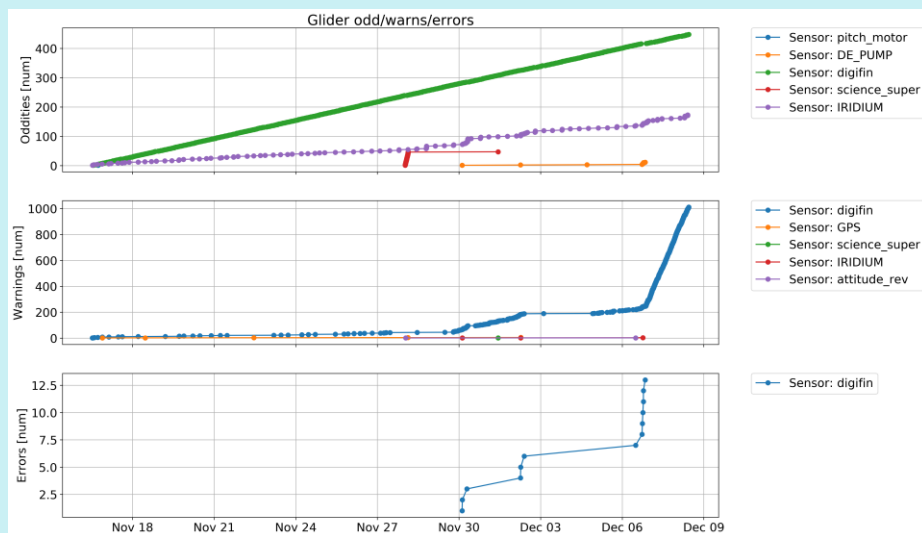
Sensor	Oditties	Warnings	Errors
GPS	0	5	0
attitude_rev	0	2	0
pitch_motor	2	0	0
science_super	47	1	0
digifin	448	1011	13
IRIDIUM	173	3	0
DE_PUMP	11	0	0

Figure 1- Glider oddities, warnings and errors

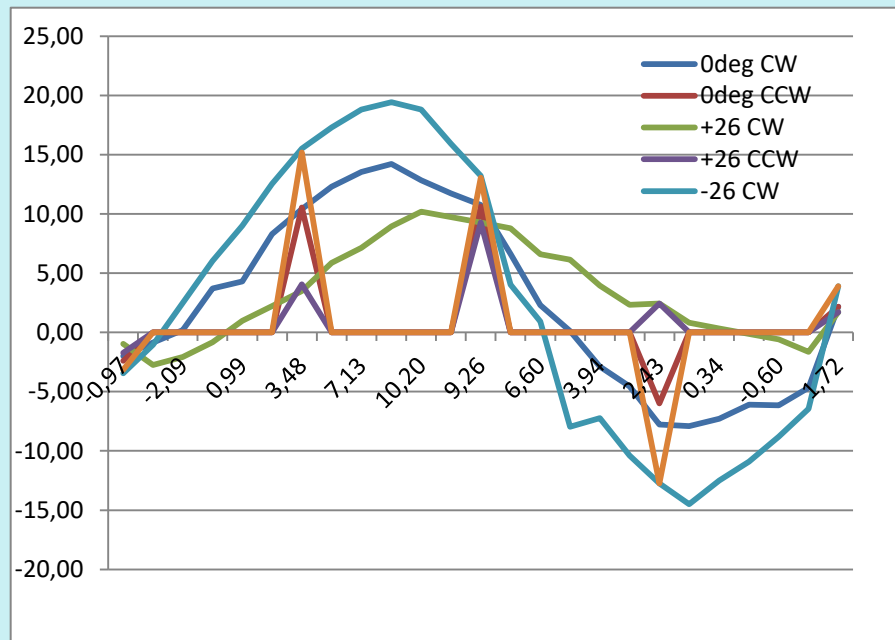
Figure 2-Error measured during Compass Error Check procedure in an electromagnetic-field-free environment located in a forest close to IMEDEA (in Esporles)
