Glider Mission Summary Report

CANALES CAMPAIGN 2018

SOCIB GLIDING NOV2018 (GF-MR-0082)

Balearic Islands
Coastal Observing
and Forecasting
System

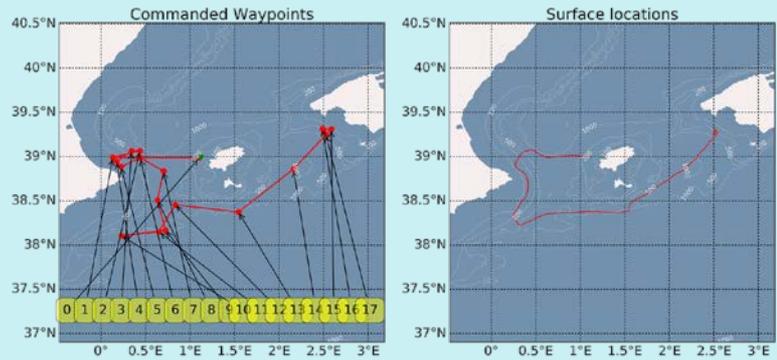
Figure 3 – Commanded Waypoints

Navigation
 It was satisfactory during the first Eivissa transect. Near Denia, glider suffered very hard currents to est-south direction. Due to this fact, it was impossible to achieve this waypoint. See Figure 2 – Commanded Waypoints and Figure 18 – Surface currents based on pre and post fix.

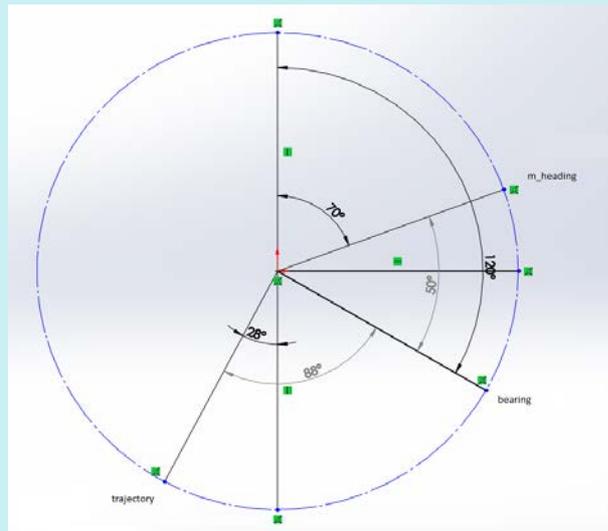
Figure 4 – Glider drift heading and position on 21/nov

In images above, **Figure 3 – Glider drift on 21/nov** and **Figure 4 – Drift on shallow waters**, glider tried to escape from currents with bearing of 120°, totally perpendicular to water current direction. But it didn't happen, currents were so hard, that digifin acted as a sail, m_heading was 70°. In this condition, glider do not work properly.

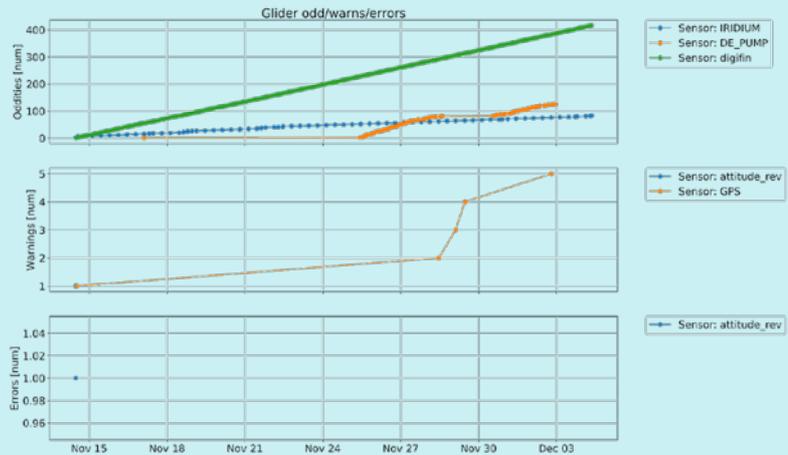
Figure 6 – Errors, warnings and oddities

Sensor	Errors	Warnings	Oddities
Digifin	0	0	416
Iridium	0	0	84
GPS	0	5	0
attitude_rev	0	1	1
DE_PUMP	5	1	125

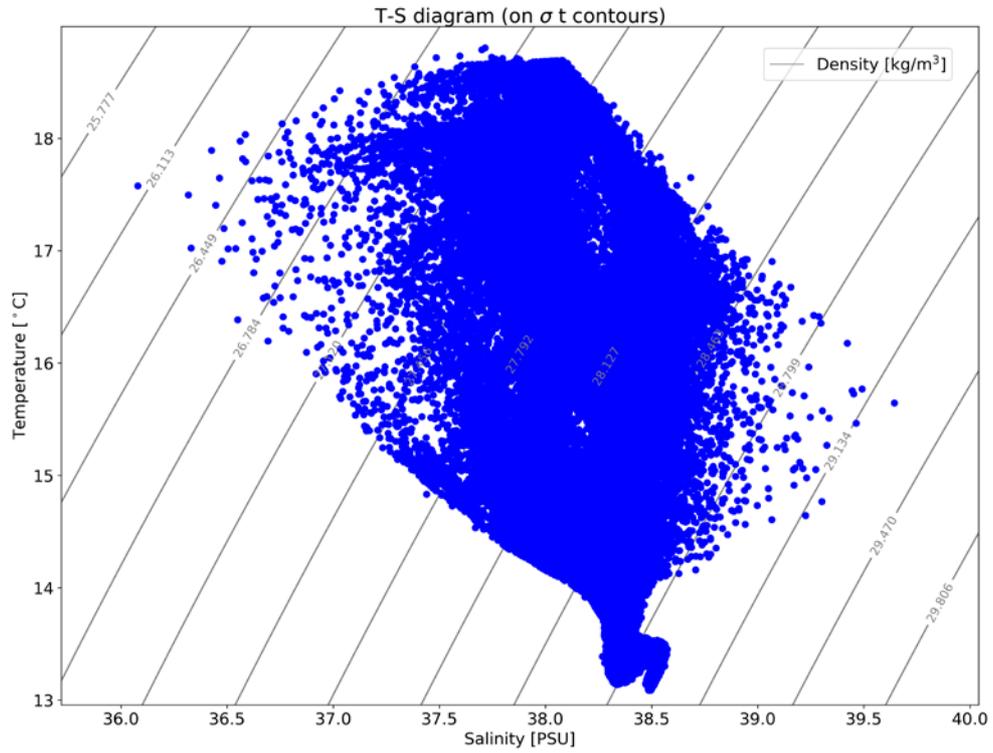
Figure 12 - T-S diagram (thermal-lag corrected)

Recovery	Premature recovery due to CTD pump malfunction. Evidence of that in TS plot. After the recovery, GFMR0083 with ideep02 started.
Vessel:	Socib I
Personnel:	1ETD + 1 GF
Location:	Palma Bay
