Glider Mission Summary Report

SOCIB_CANALES_MAY2016 (GF-MR-0045)

Balearic Islands
Coastal Observing
and Forecasting
System

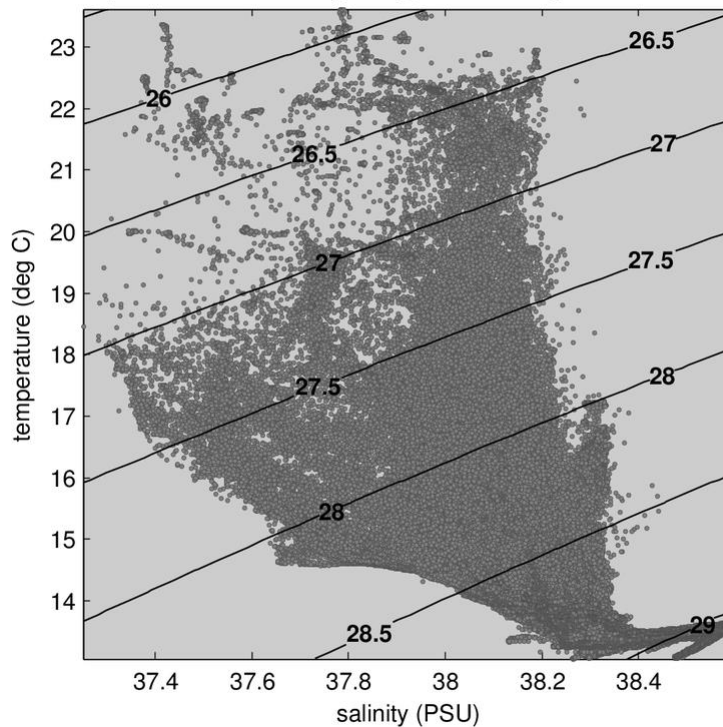
Plot 4 – T-S diagram (thermal-lag corrected)

(Plot4 shown here is the result of a Quality-Control method applied by SOCIB's Data-Center to filter suspiciously low salinities that were totally out-of-range in the Balearic Channels region - see a miniaturization of the original-plot below-.
