Glider Mission Summary Report

CANALES CAMPAIGN 2018

SOCIB GLIDING NOV2018 (GF-MR-0082)

Balearic Islands
Coastal Observing
and Forecasting
System

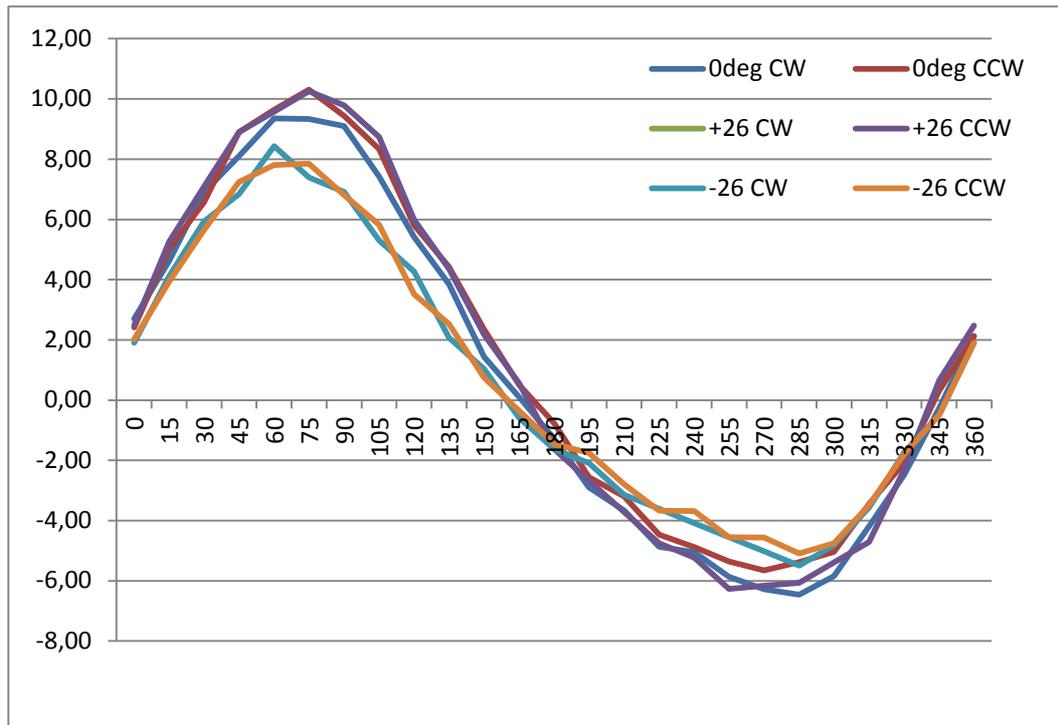
Figure 1 – Compass Error Measurement

Step	Status	Comments
Hardware check	ok	Oil flux wrong direction. Known problem. Not solved during last refurbishment
Comms check	ok	SMS service out of order
Batteries check	ok	Eltec
Ballasting check	ok	Target density: 1025.158 g/L Tank density: 1027.64 g/L
Final sealing check	ok	Leak oil system
Fileset check	ok	Added the new TWR's SFMC dockserver number (First time since SFMC license was purchased)
Harbor check	ok	Performed in IMEDEA
Compass Error Measurement	NA	Not performed. Figure 1 belongs to previous mission GFMR0057

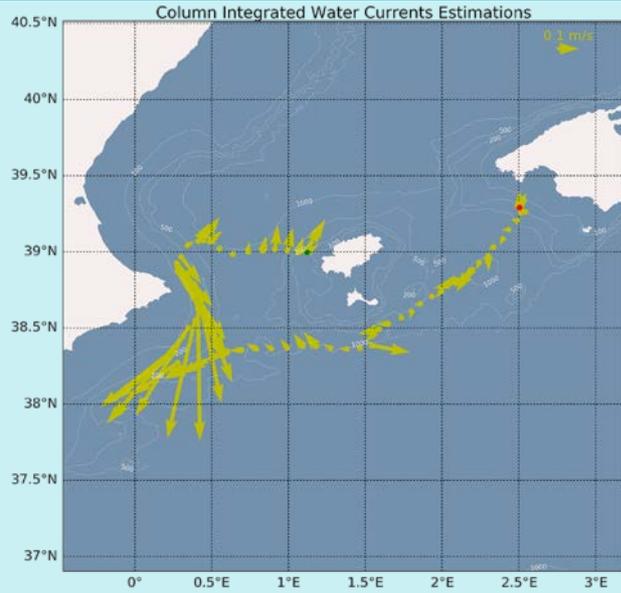
Figure 2 – Integrated Water Currents

Navigation
 It was satisfactory during the first Eivissa transect. Near Denia, glider suffered very hard currents to est-south direction. Due to this fact, it was impossible to achieve this waypoint. See Figure 2 – Commanded Waypoints and Figure 18 – Surface currents based on pre and post fix.
