Glider Mission Summary Report

SOCIB_CANALES_OCT2012 (GR-MR-0012)

Balearic Islands
Coastal Observing
and Forecasting
System

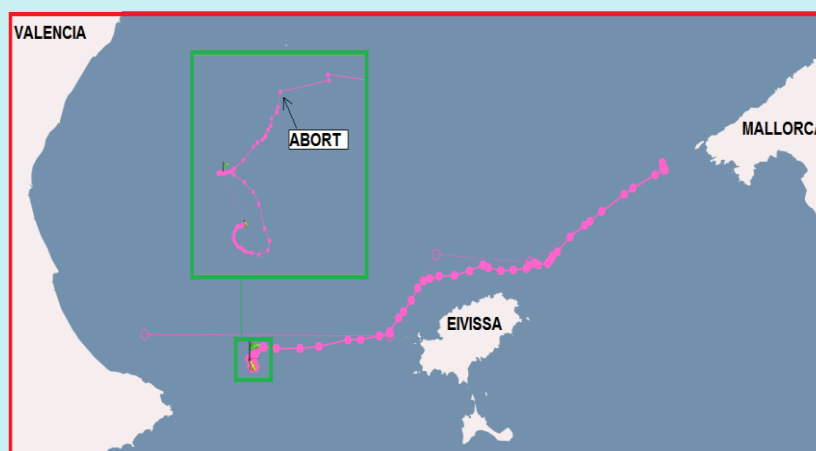
Mission Summary

(Map providing detailed overview of Survey Area and traced Flight Path with surface points if possible)
